Title: An Evaluation of the ASM2000 software

Author(s): Mclean, Thomas Donaldson
Gildea, Timothy R.

Issued: 2021-07-12

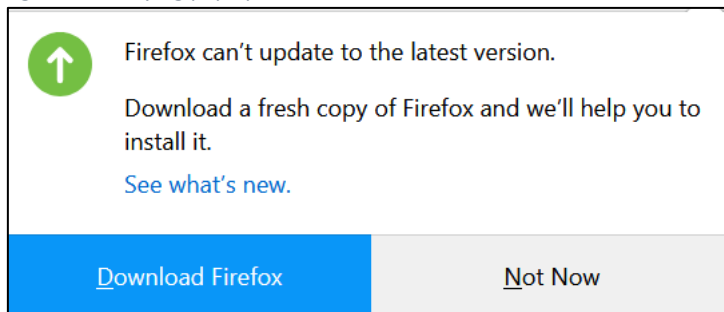
Figure 7. Annoying pop up text box

- 1) A nuisance text box asking if an update of the FireFox browser was desired popped up on a regular basis (Fig.7) and had to be acknowledged to make it (temporarily) disappear. Despite several efforts, this message could not be permanently disabled.

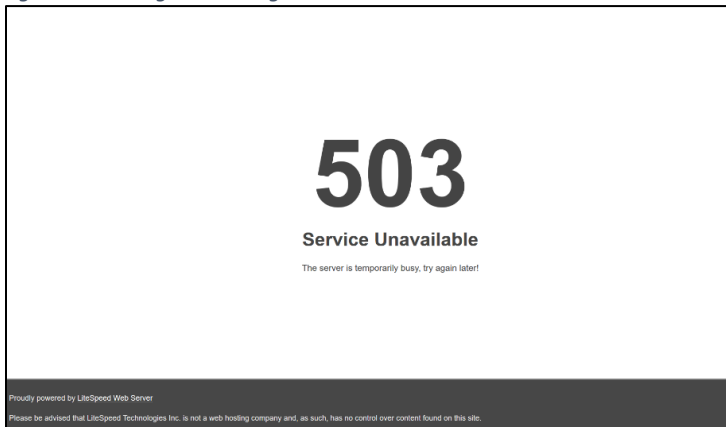
Figure 8. Message indicating browser had crashed

- 2) Frequent logouts or tab crashes of the Firefox browser were observed – about one every 7-10 days on average. They were characterized by three different types of tablet displays. The most frequent was the log in screen (Fig. 3) but the messages shown in Figs. 8 and 9 were also seen. Logging in again or refreshing the browser usually restored normal operation (Fig. 4). Though in a few instances (~ once a month), the tablet's web pages were sluggish to respond to user requests e.g. taking 15-20 s to execute a command. But it was verified that the CAM could annunciate an acute alarm condition while in this sluggish mode. Normal responsiveness could be restored in about 2 minutes by closing the browser, closing and restarting the Virtual Box Manager and reopening the browser.

However, in one instance of a "503" crash (Fig. 8), a casual glance of the restored browser appeared to show normal operation had been resumed without the need to restart VB and the browser. However, when a filter change and testing of the horn and light functions were attempted, the tablet failed to execute these requests despite the display of reassuring messages (e.g. "filter change command sent"). A restart of VB and the browser was needed to restore normal operation.
